Manhole Inspection Summary

Manhole # S33S__058MH

Location Address: **rear 1316 race st**

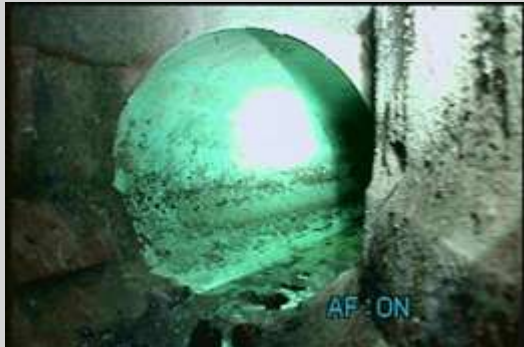
12 O'Clock Outflow

10 in. Circular Gravity Sewer
Pipe Out @ 12 O'Clock

Pipe Height: 0 (in.) Direct

Pipe Material: PVC ☐ Pipe Lined

Invert Depth: 13.58 (ft.) Flow Characteristics: None

Deposits: ☒ None ☐ Mud ☐ Sludge ☐ Debris ☐ Grease

Infiltration: None Pipe Seal Cond: Unknown

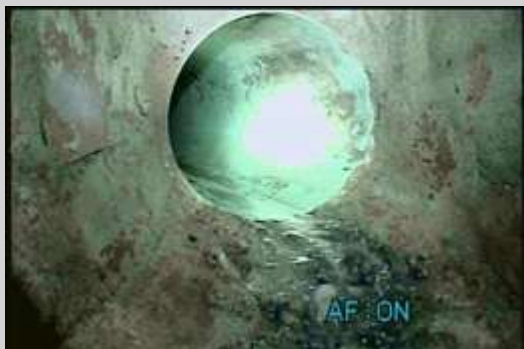
3 O'Clock Inflow

8 in. Circular Gravity Sewer
Pipe In @ 3 O'Clock

Pipe Height: 0 (in.) Direct

Pipe Material: PVC ☐ Pipe Lined

Infiltration: None Pipe Seal Cond: Unknown
